A Special Wetland Eversource Energy's Atlantic White Cedar Mitigation Project - The 1st Year

BSC Group, Inc.

THE PROJECT: Eastern Connecticut Reliability Zone 5 400/500 Lines Rebuild

Overview of the 400/500 Lines Rebuild Project

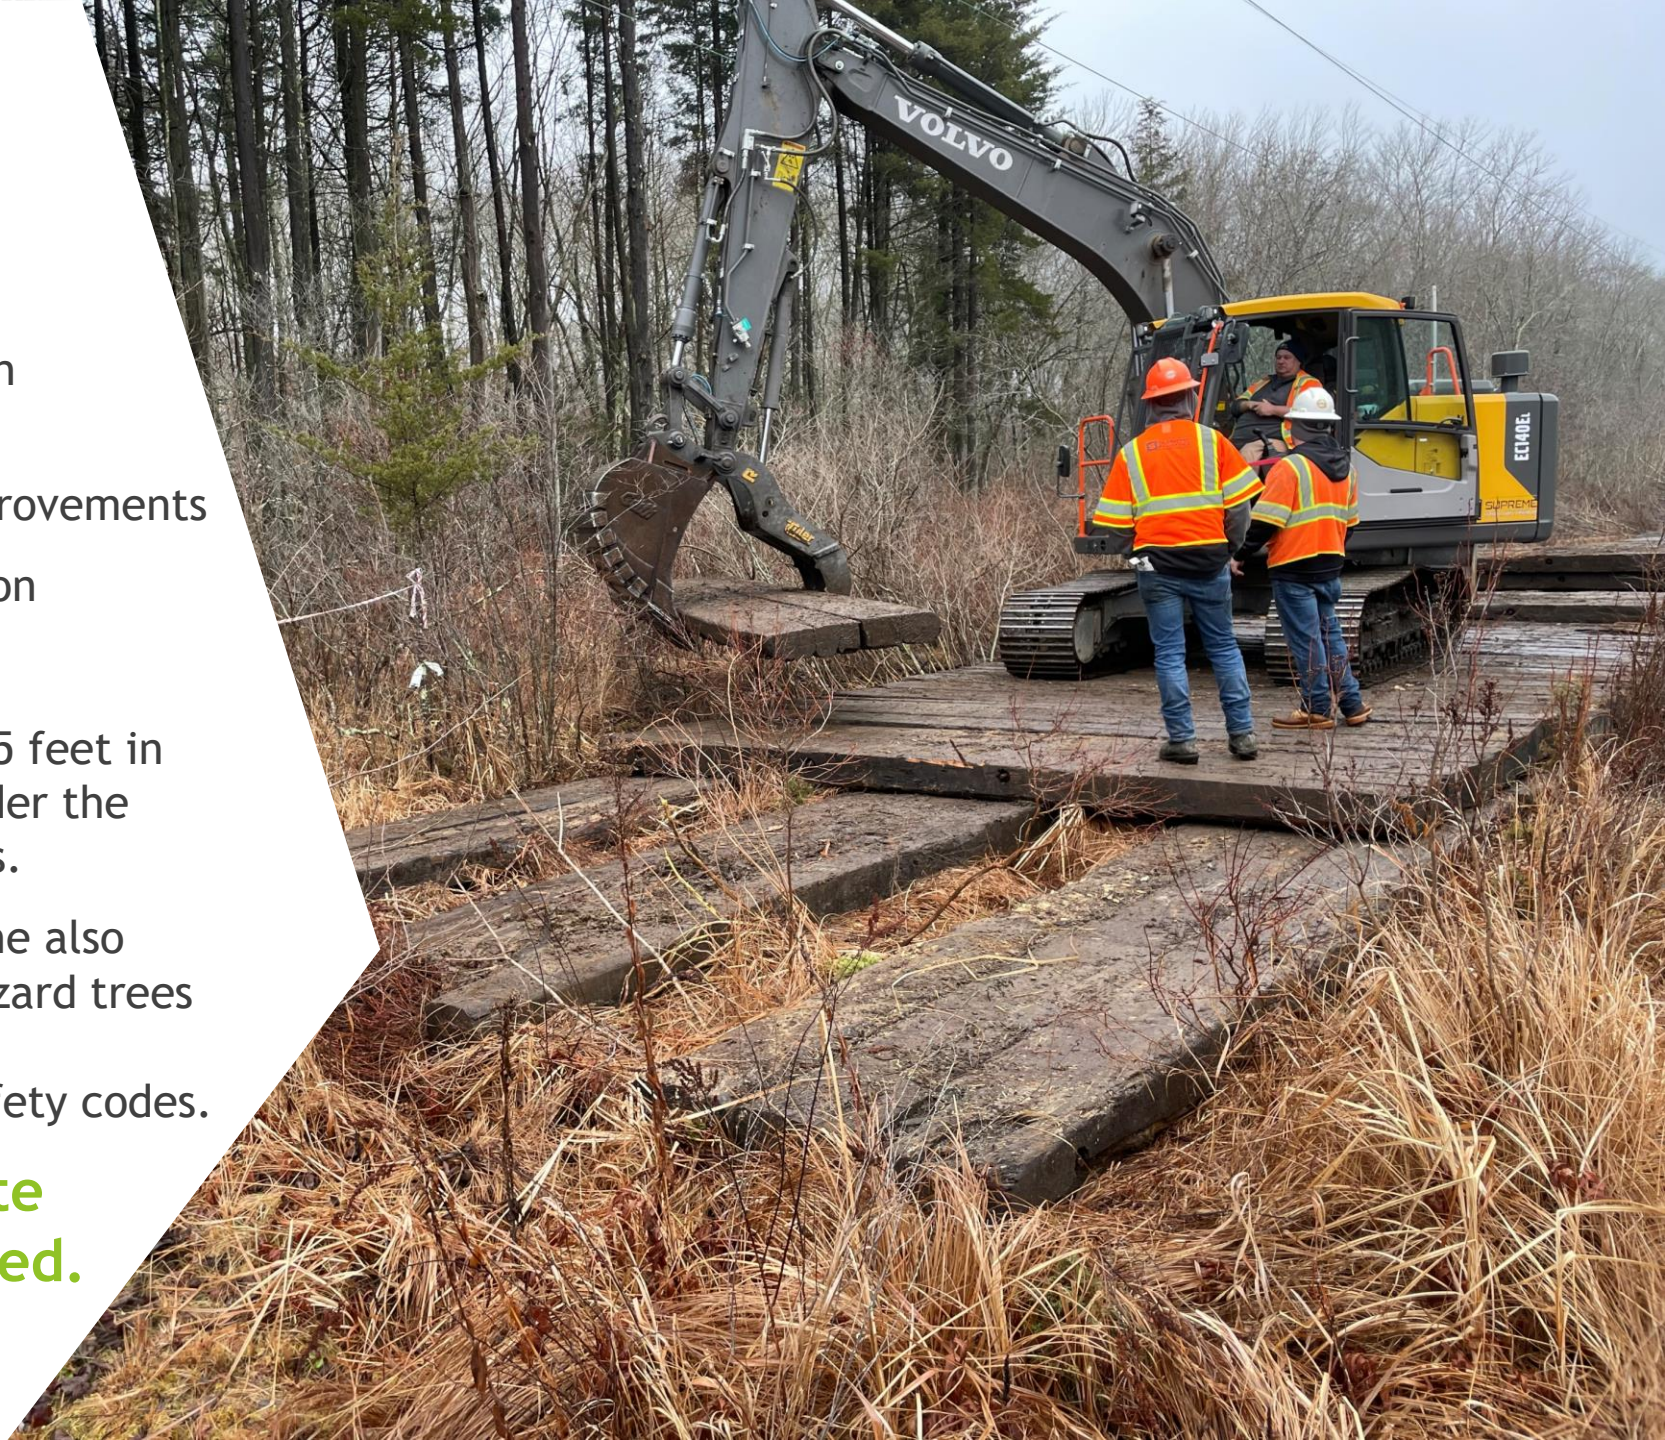
Feller-bunchers were used to extract AWC without causing disturbance to the surrounding areas.

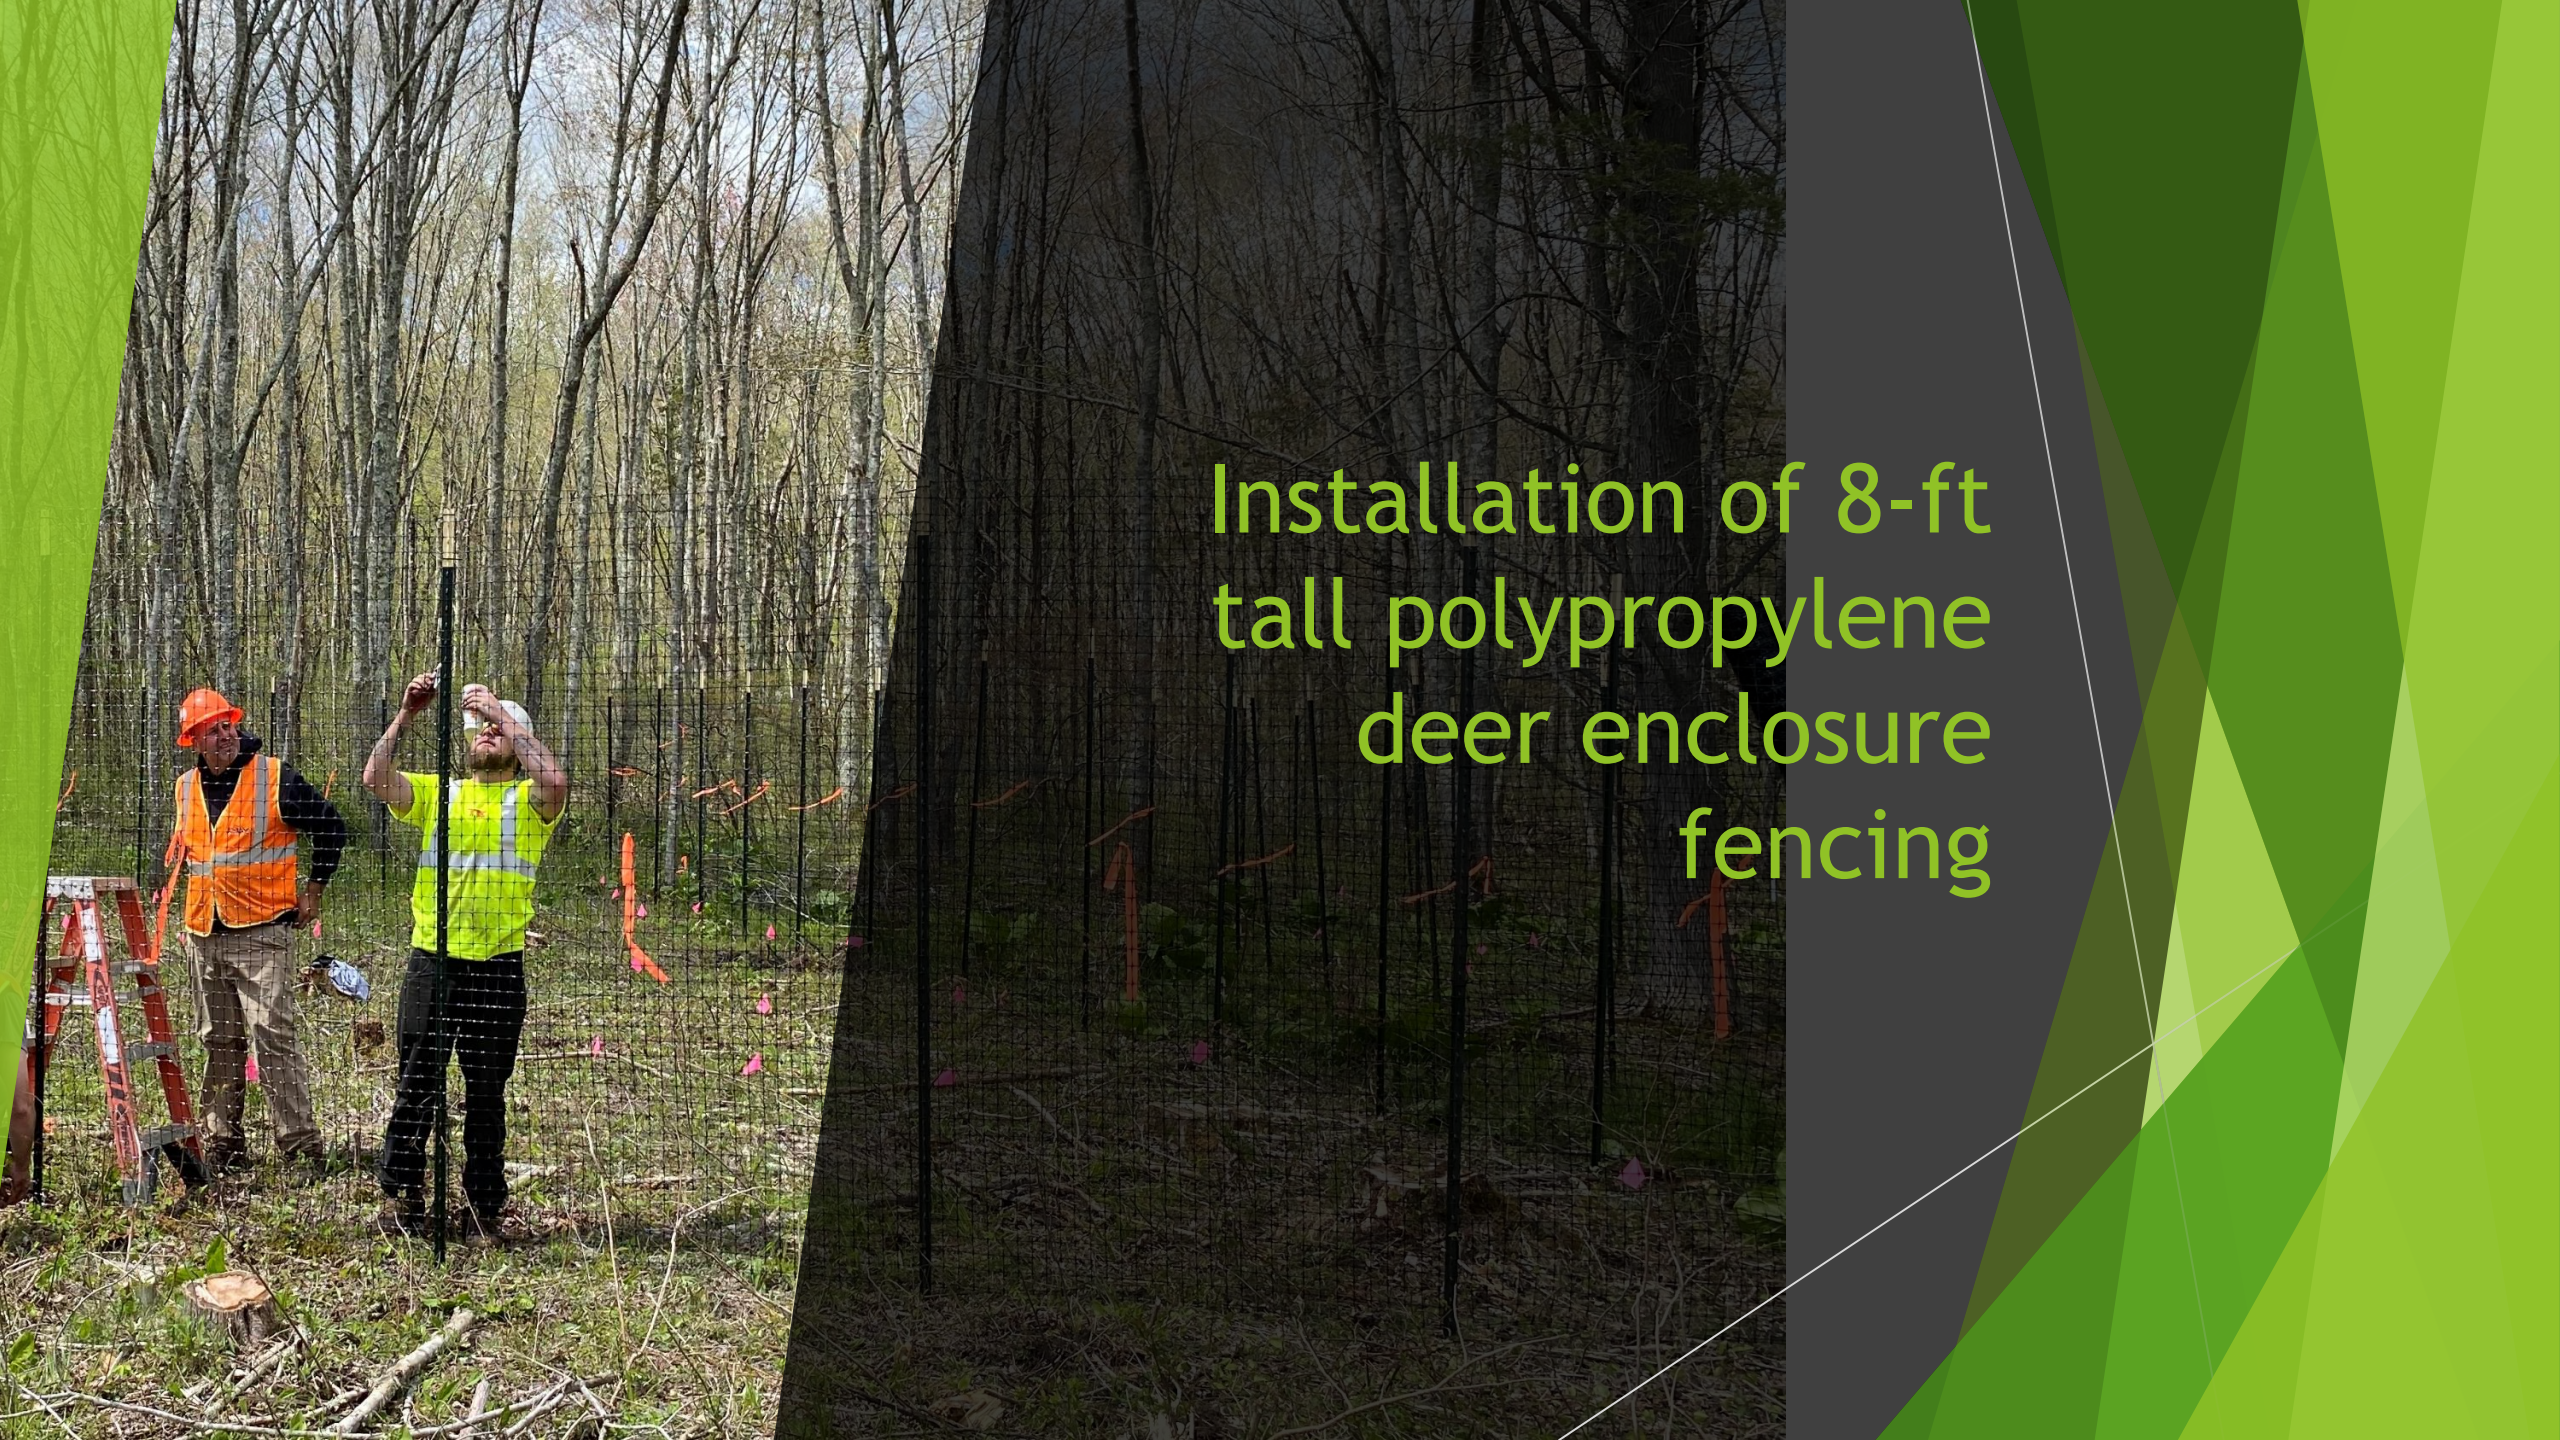
Installation of 8-ft tall polypropylene deer enclosure fencing

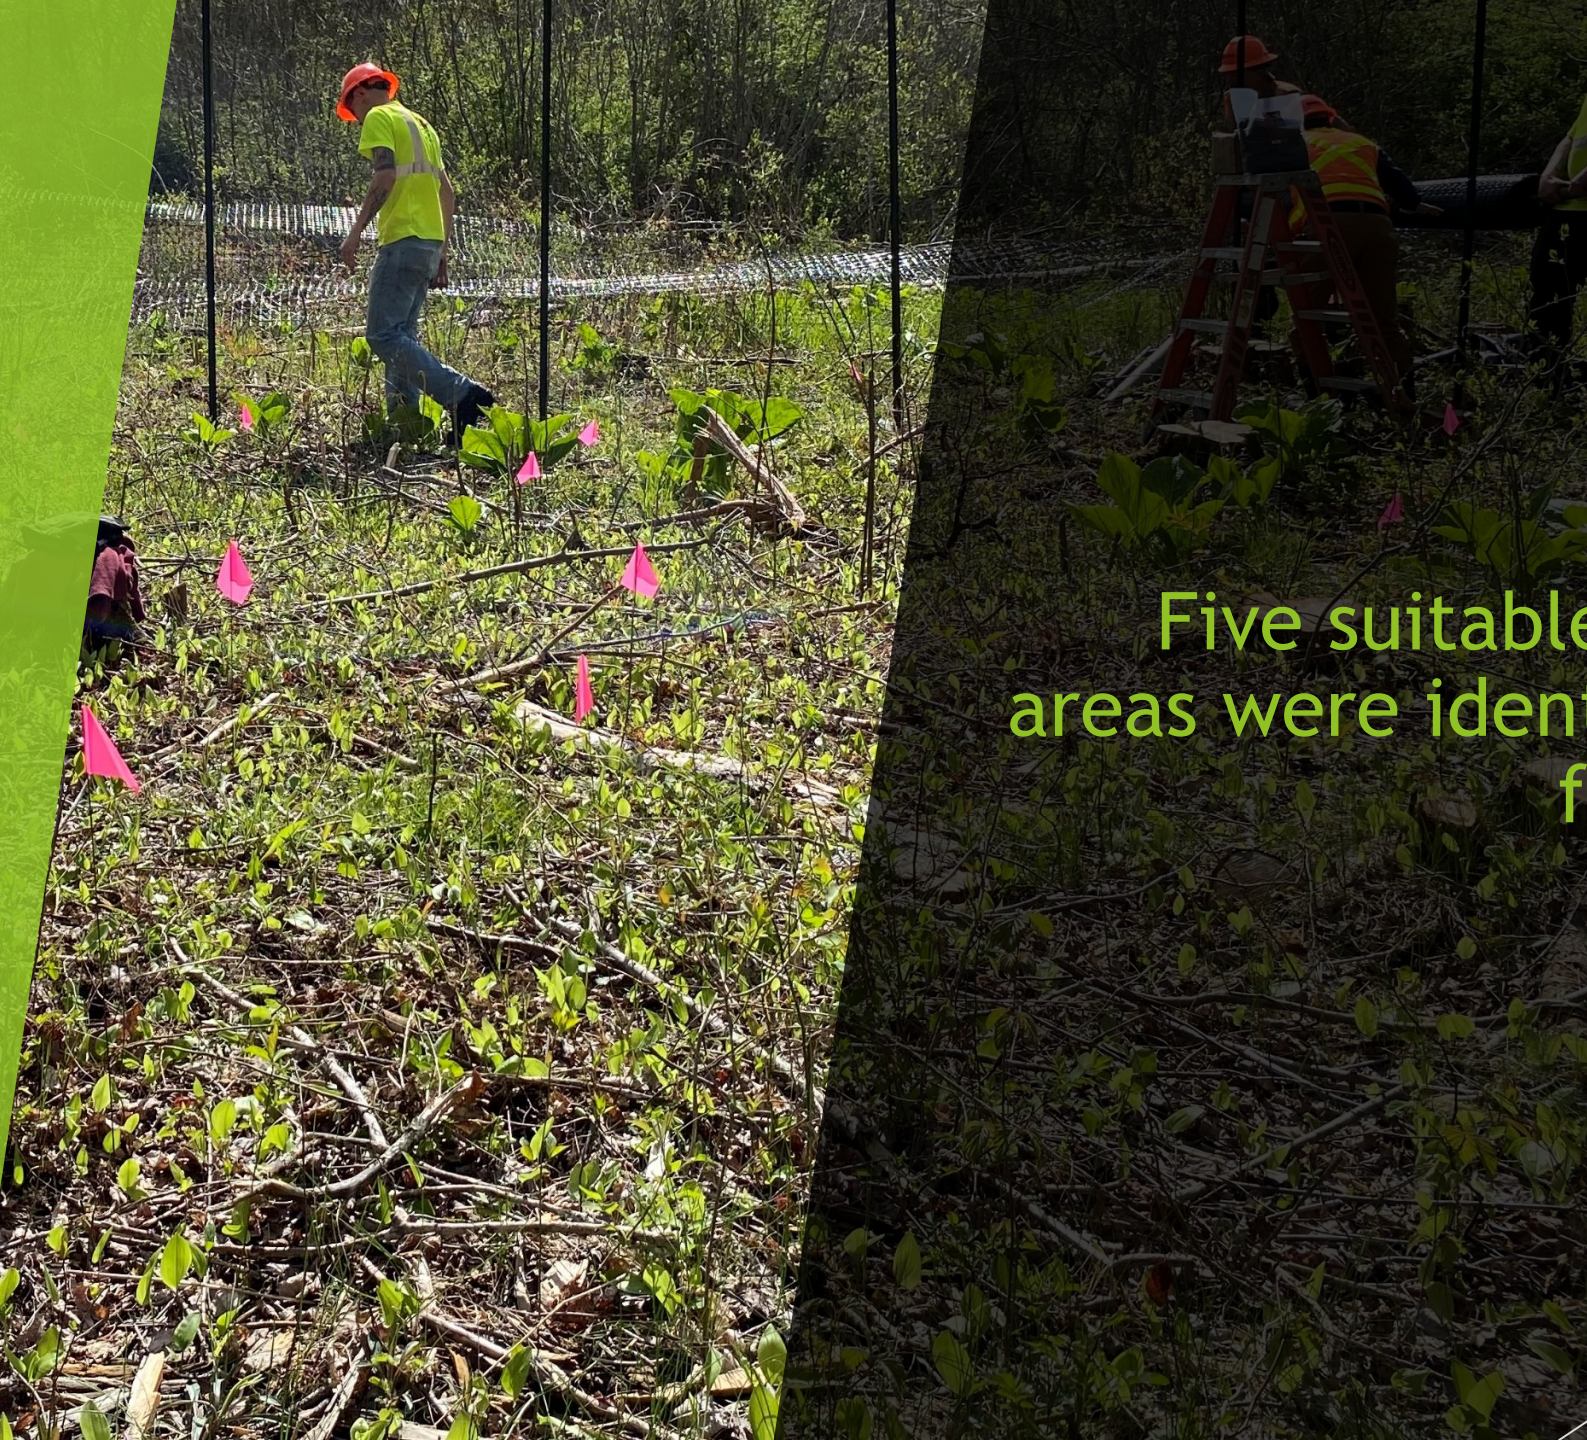
Five suitable planting areas were identified and fenced off

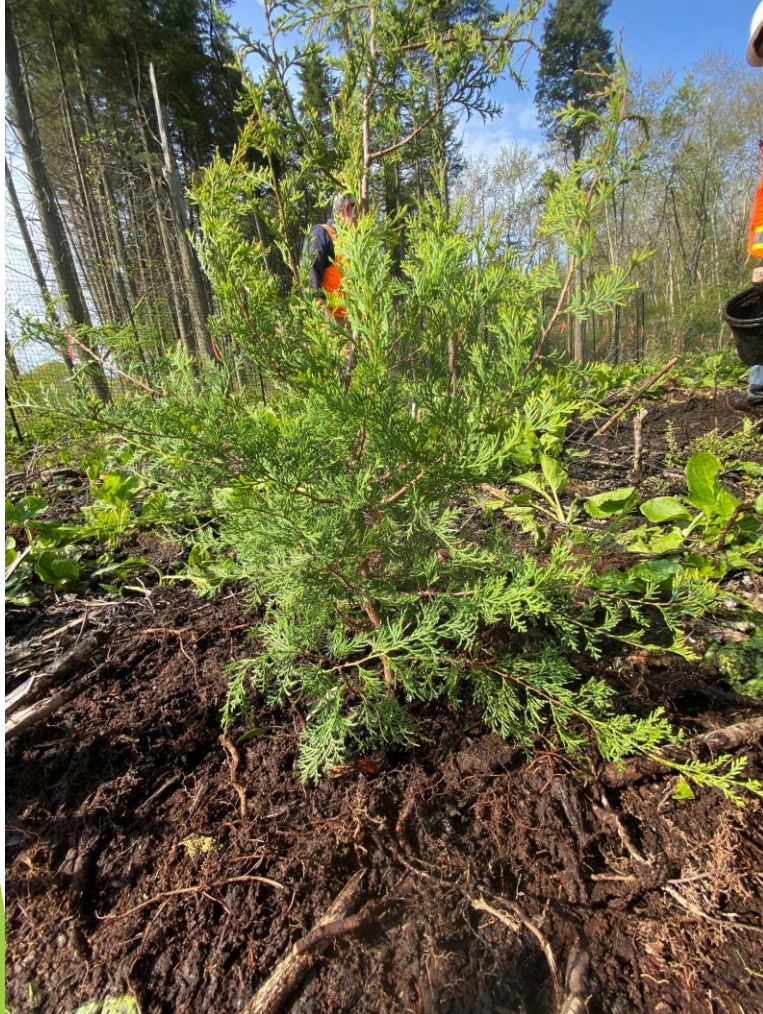
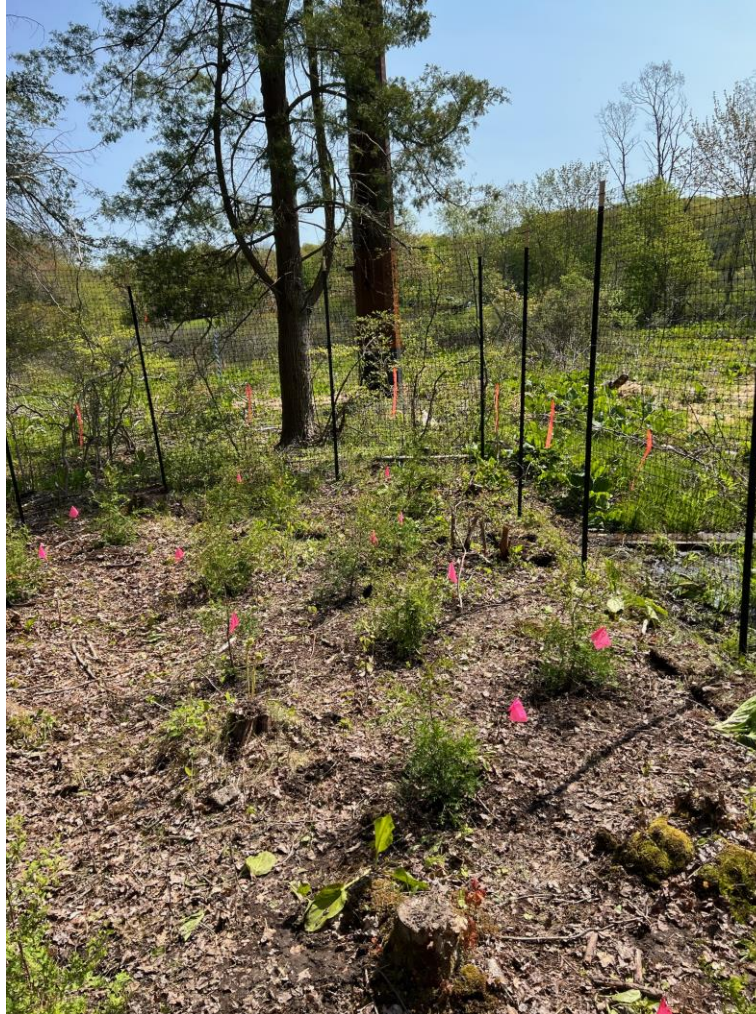
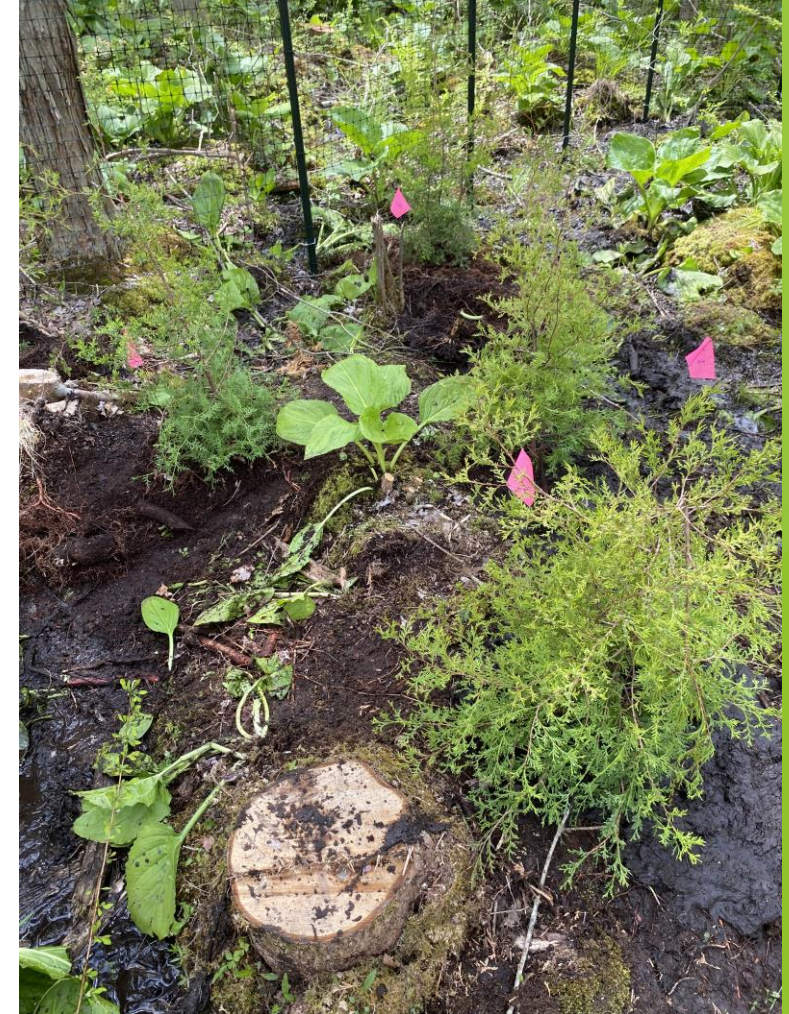
159 AWC saplings
were planted in
April 2023

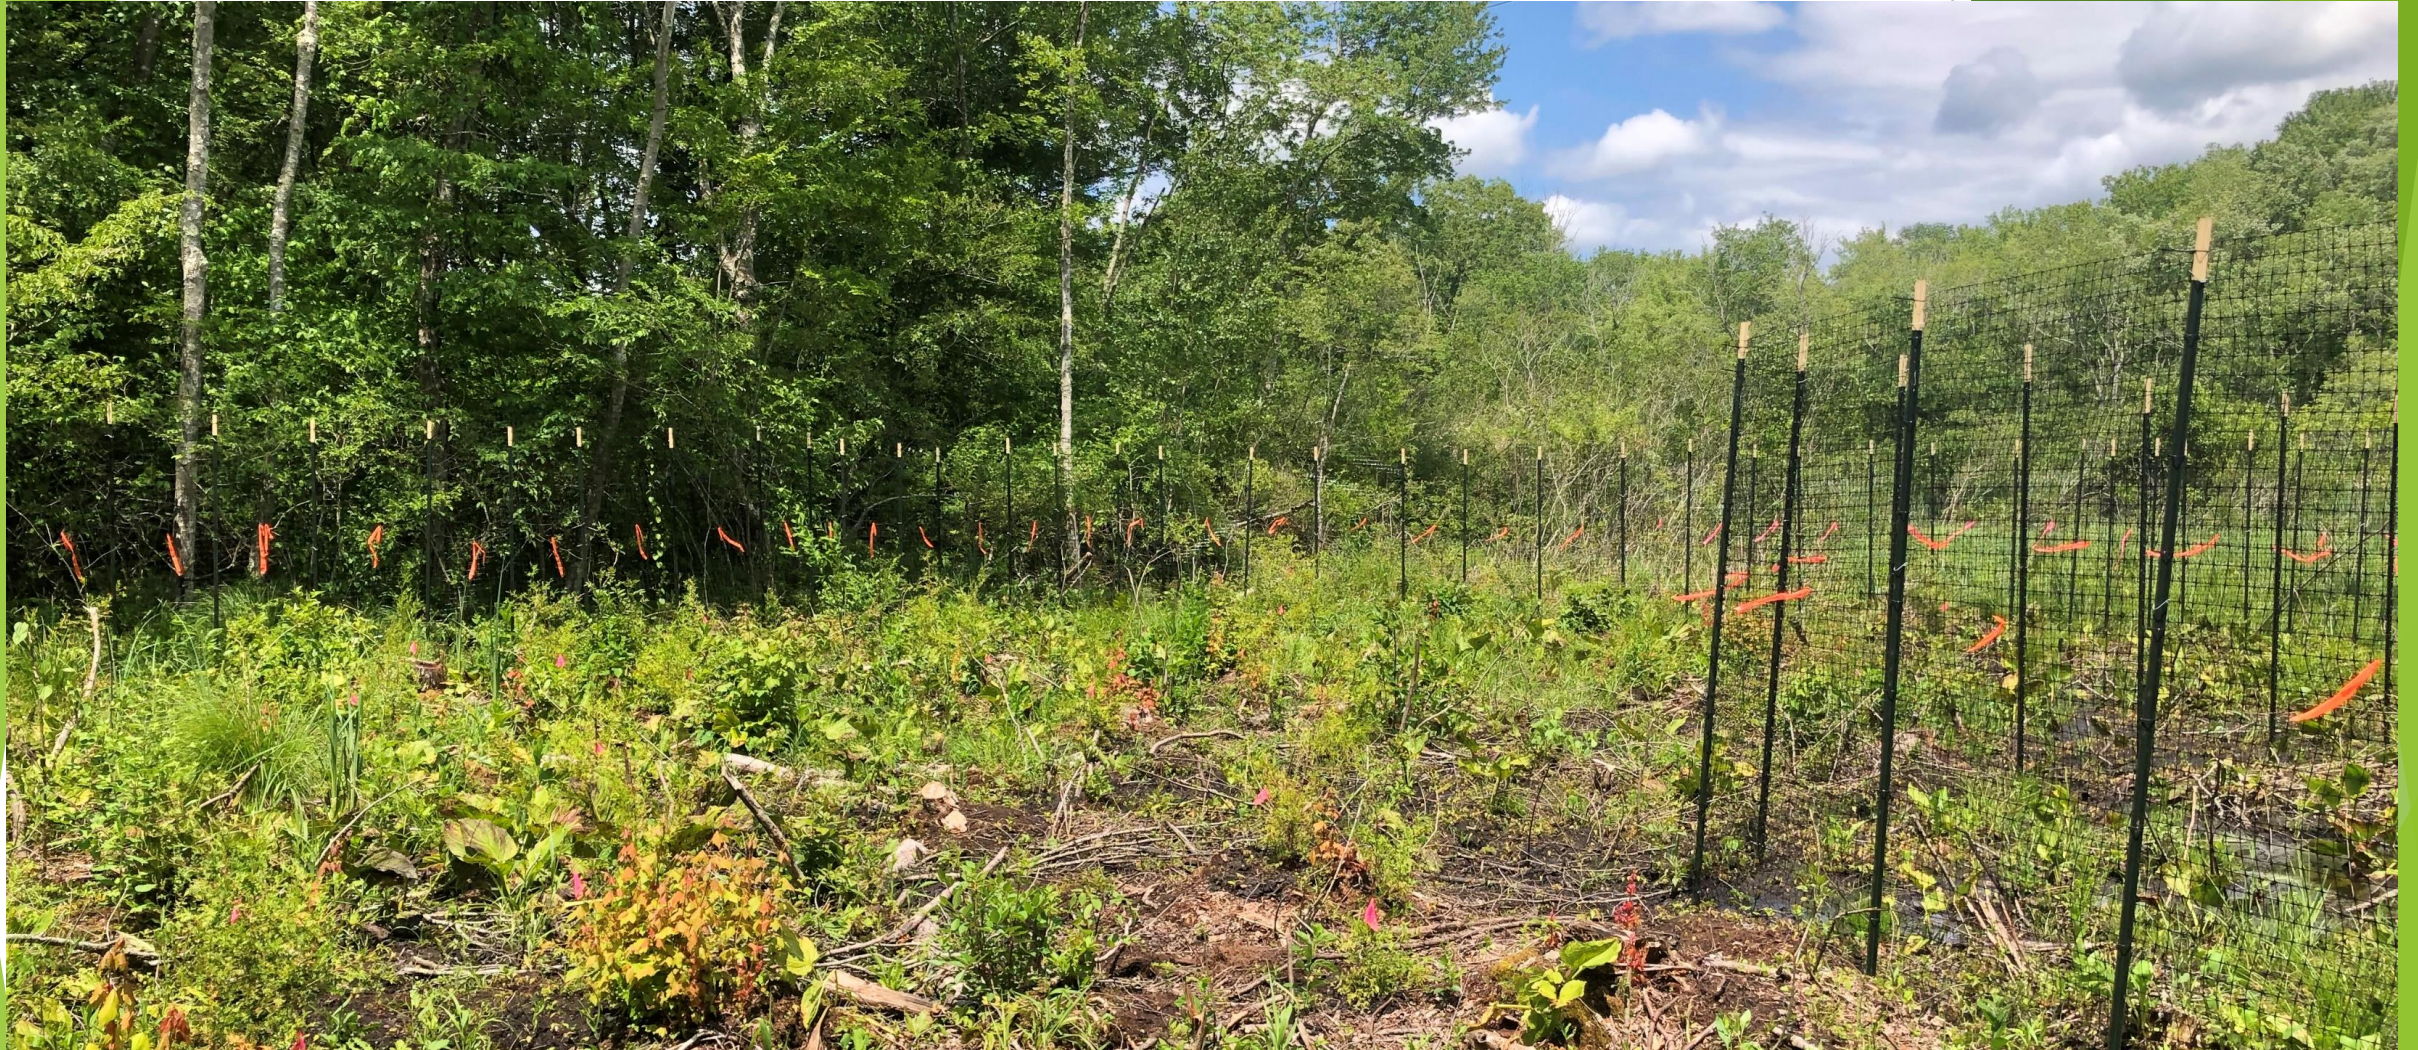
June 2023

- The height/growth of the AWC saplings was determined with a tape measure (to the nearest half-inch).
- Phenology was recorded based on visual observation of fruits or lack thereof.
- Overall comprehensive health:
 - 3 - a sapling with 75% or more green foliage
 - 2 - a sapling with less than 50% yellowing foliage
 - 1 - a sapling with more than 50% yellowing foliage
 - 0 - a sapling with brown foliage or non-surviving sapling
- Vegetative competition was estimated visually and reviewed based on the number of sides and overall coverage of the area experiencing competition by woody vegetation.

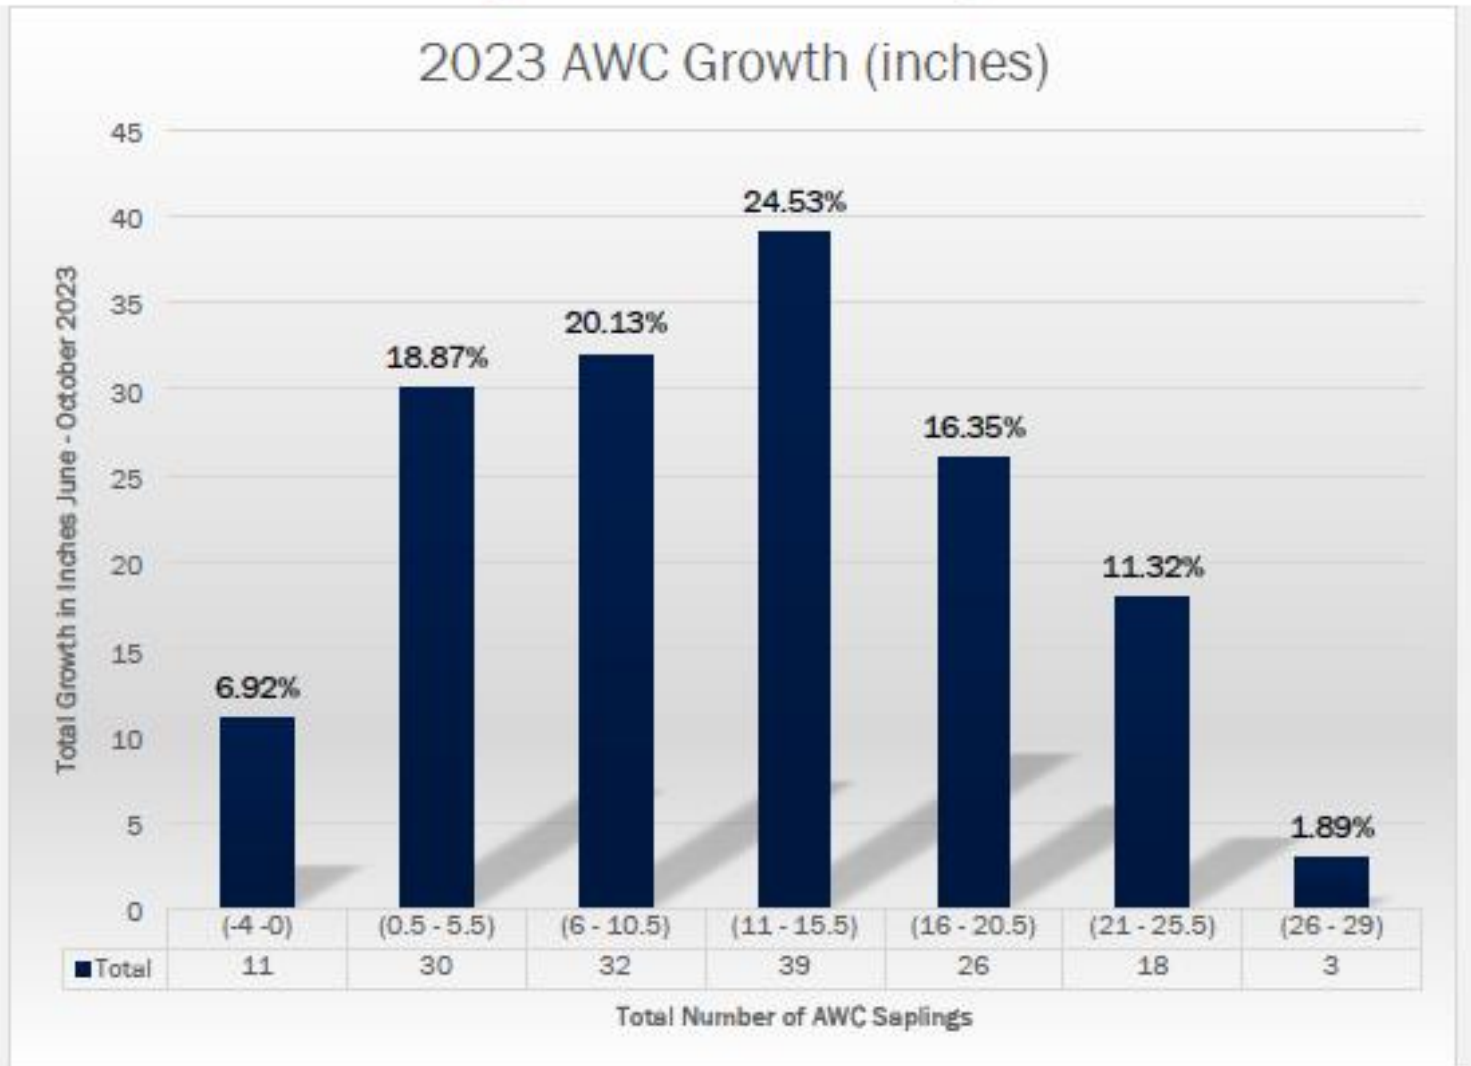
GROWTH:

During the 2023 growing season, the majority of the AWC saplings grew. The annual growth ranged from 0.5 to 29 inches

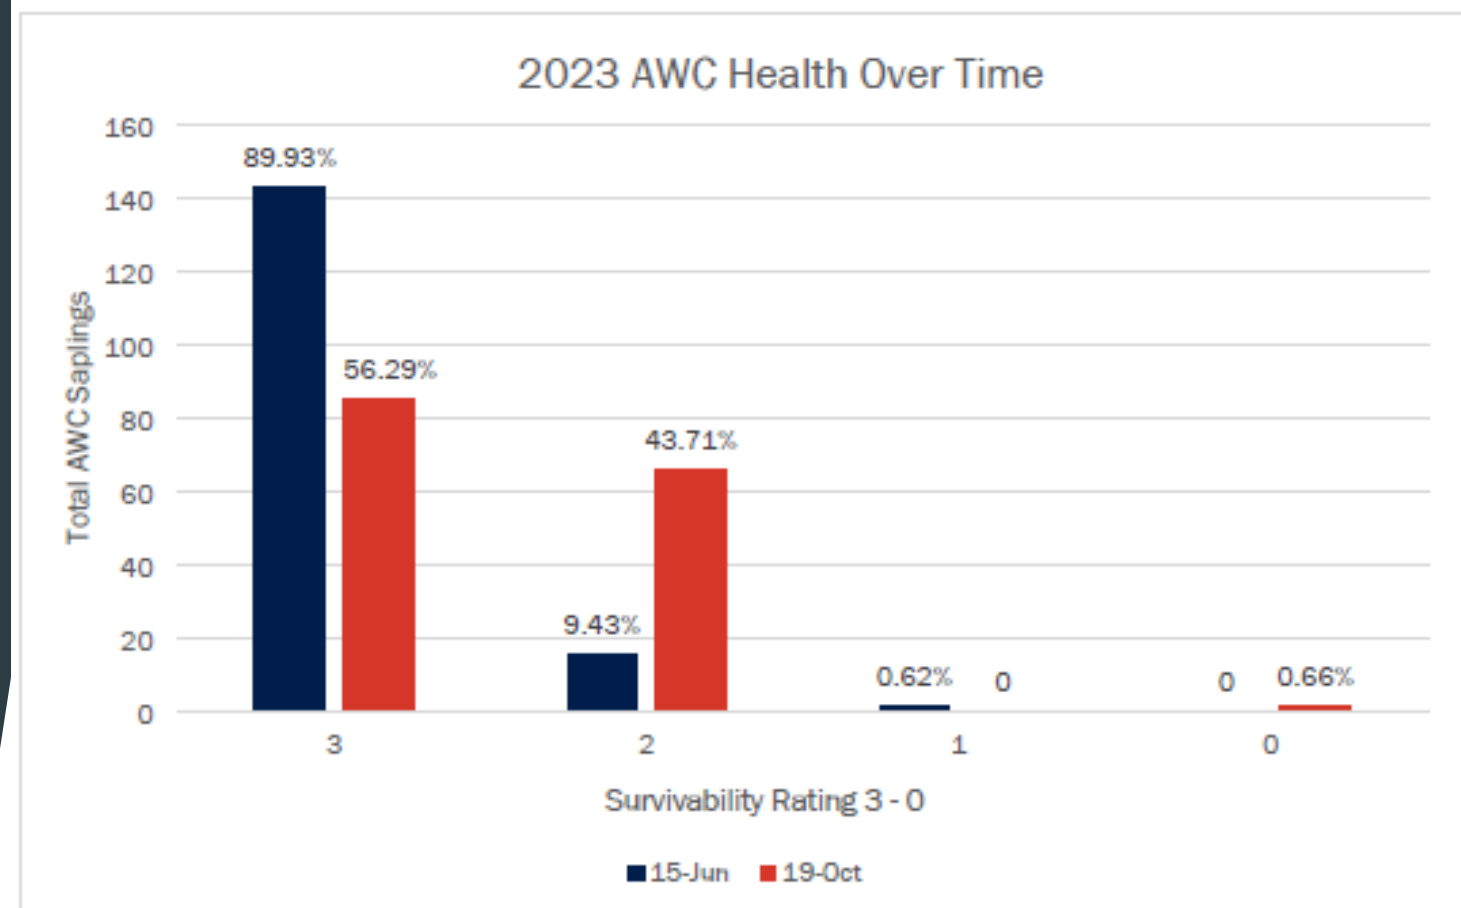
COMPREHENSIVE HEALTH:

June - 89.93% of the AWC saplings were categorized with a “3” survivability rating.

October - Survivability in the “2” category increased from 9.43% to 43.71%.

Only 1 sapling did not survive.
